NON-DESTRUCTIVE TESTING OF THE HISTORIC TIMBER ROOF STRUCTURES OF THE NATIONAL MUSEUM IN STOCKHOLM,

NON-DESTRUCTIVE TESTING OF THE HISTORIC TIMBER ROOF STRUCTURES OF THE NATIONAL MUSEUM IN STOCKHOLM, SWEDEN

The National Museum in Stockholm is Sweden's leading museum of art and design. Behind the now closed doors of the National Museum and its construction coverings a renovation project is taking place, which began in 2014 and will be completed in 2018. The renovation project will create a modern museum, a brighter atmosphere for the arts and for its visitors. Part of the renovation project was to design and upgrade the timber roof structure for new loads according to Eurocode 5. As the roof structure was originally built in 1860, it was important to evaluate the condition and mechanical properties of the original load-bearing timber members. The roof structure, which is of main interest, comprises roof trusses and lantern structures.

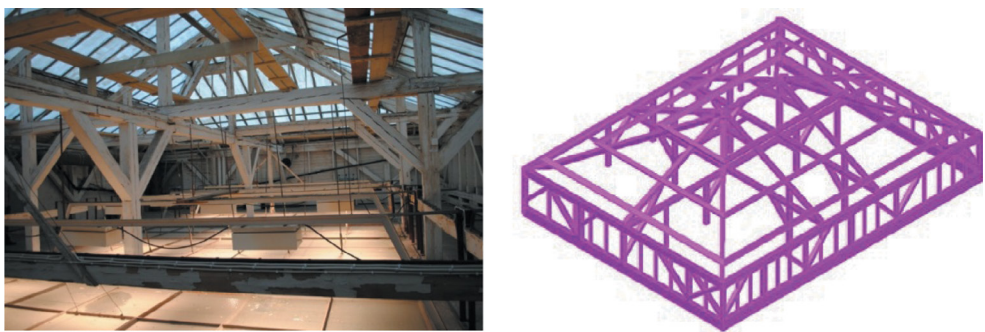
Figure 3: The roof structure no. 1.

The roof structure type 1 includes two transversal frames and one longitudinal frame carrying these two transversal frame structures (Fig. 3). The investigation campaign included a 3D scanning and detailed geometrical survey. Data collected during the investigation campaign were used for the preliminary analysis of the roof structure.

For the structural assessment calculations of two lanterns roof structures a numerical 3D model was prepared based on a 3D-CAD model (Figs 1 and 2). The roof structure no. 1 is presented in Fig. 3, while the roof structure no. 3 is presented in Fig. 5. A 2D numerical

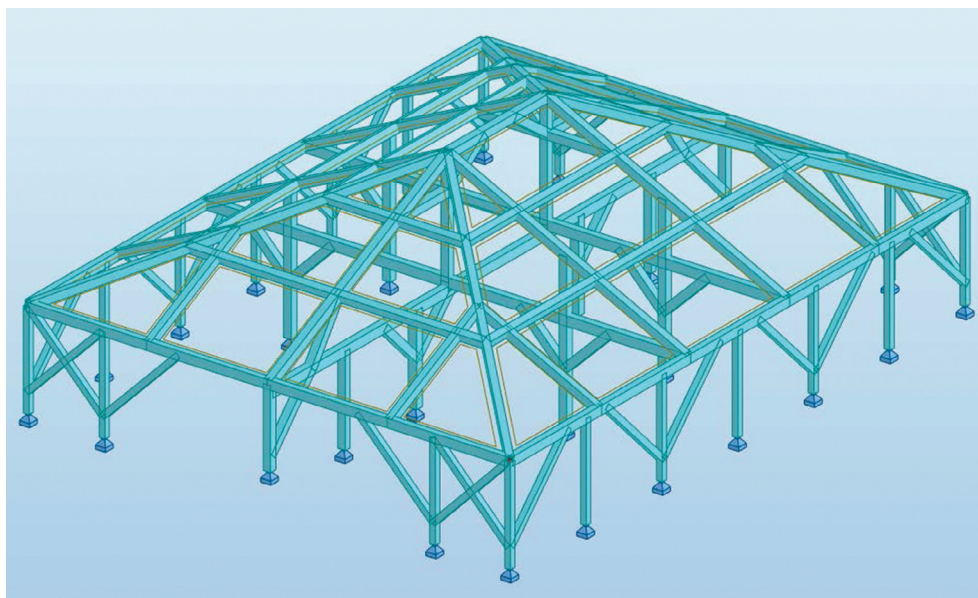
Figure 9: 3D numerical model

For the structural assessment calculations, the geometrical survey data were used to prepare numerical 2D and 3D models. Figures 9 and 10 present the 3D numerical model of roof structure type 1. The structural 3D modelling process did not focus on details (carpentry joints and connections) modelling. The structural analysis of roof types 1–3, with timber strength class assigned to C30, showed satisfactory results both in ULS and SLS designs. Only in roof type 1 four rafters and purlins were removed and exchanged with new glulam beams due to architectural design of new glass roof structure. Purlins in roof type 3 were also removed and exchanged with new glulam beams due to the same architectural design of glass roof structure. Roof structure type 2 was neither strengthened nor rebuilt from original design.
